Tasman Group Services Pty Ltd
Wellington Road, Longford, Tasmania.

This report presents the results of the review of the paunch management practices commenced at the Tasman Group Service Pty Ltd (TGS) meat processing facility located in Longford, Tasmania in April 2007. The report summarises the site's key processes, waste paunch source and management and final treatment activities.

RIES Environmental was engaged to undertake an independent review and reporting of the site's paunch management practices.

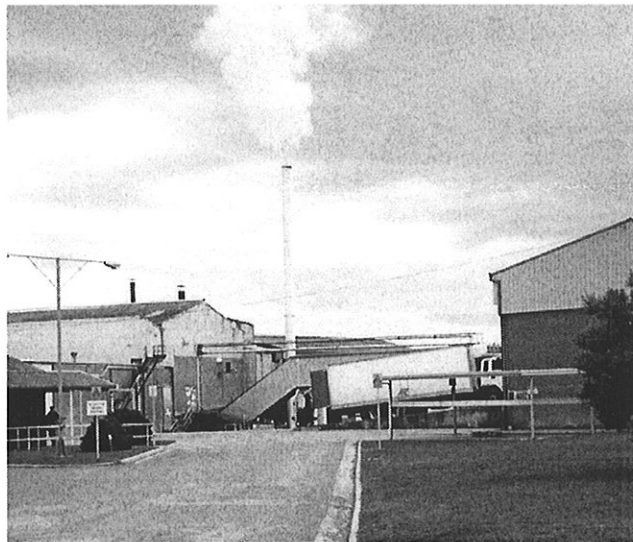
Fig: 1

Approximately 80–85% of total energy consumed at the site is provided by natural gas (15%) and thermal energy from the combustion of fuels in the **on-site solid fuel-fired boiler** (fig.1). The remaining 15–20% of energy is provided by electricity, which is used to operate equipment in the slaughter and boning areas, for by-product processing, and for refrigeration and compressed air.

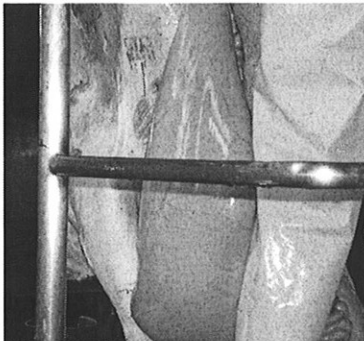
Fig 2: Paunch being removed.

After dehairing and hide finishing, the carcasses pass to the evisceration area, where the **stomachs are opened** (cattle *paunch weighing about 40 kg) and the viscera removed (the paunch is then directed by conveyor for splitting). The breastbone is split and the plucks (heart, liver and lungs) are loosened and removed. The carcasses are then de-headed and split along the backbone. Finally, the carcasses are chilled rapidly overnight before the subsequent processes of cutting and boning takes place.

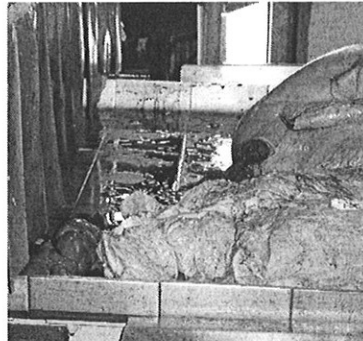
Fig 3: Paunch on conveyor.

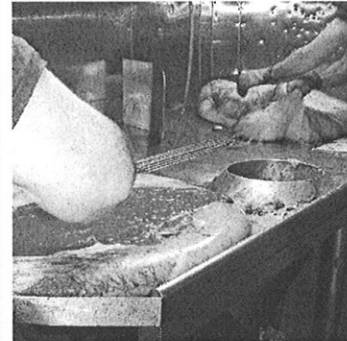
Fig 4: Paunch splitting.

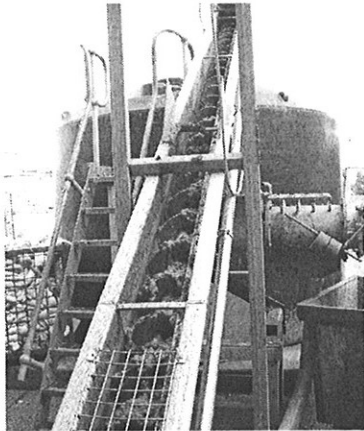
Following the splitting process, the paunch is washed into a screw conveyor and diverted to the paunch screw press (fig 5) where the paunch is dewatered to 12% dry solids, which represents a volume reduction of 88 %. The screw press is designed specifically to handle paunch material from abattoirs and has low energy consumption (5kW motor). The design capacity of the press is approximately 25kg/hr (200kg/day)

Fig 5: Paunch screw

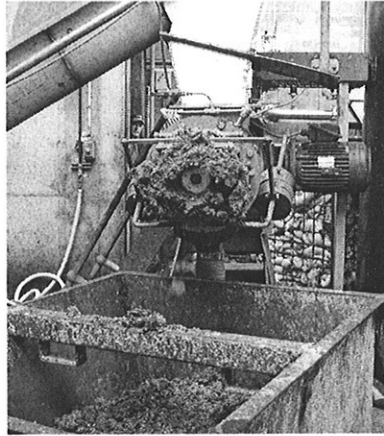
Fig 6: Paunch press

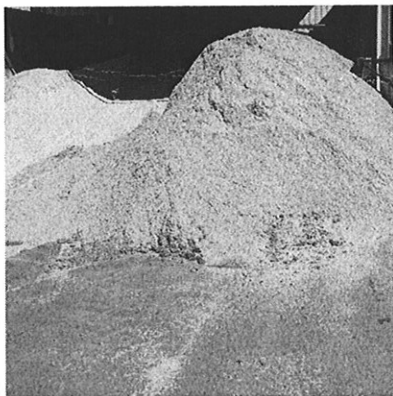
From the press, the dry paunch drops into a skip, which when full is taken by forklift to the solid fuel storage area where a front-end loader/tractor progressively mixes the paunch with sawdust. The mixed material is then suitable as a fuel for the solid waste boiler.

Fig 7: Paunch material and sawdust mix

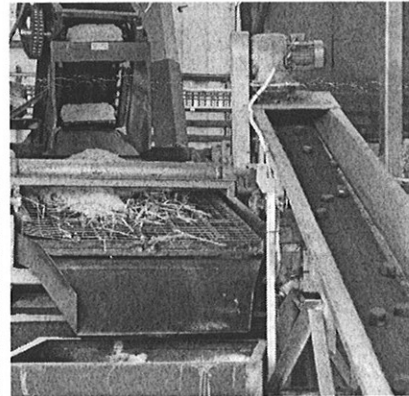
Fig 8: Sawdust shaker and Briquette conveyor.

In the event that the combined sawdust and paunch material moisture content is too high, briquettes may be added to assist the burning process.

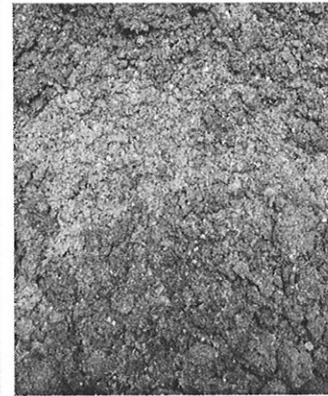
Fig 9: Pressed paunch
